Manhole Inspection Summary

Manhole # S15II1011MH

Location Address: **GREEN SPRING AVE**

Cross Street: **COLD SPRING LN**

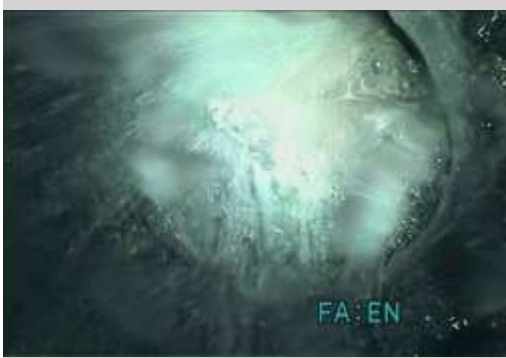
Inside the I2

☒ **Debris** (not Condition related)

☒ **Corroded**

Corroded steps. Bench debris.

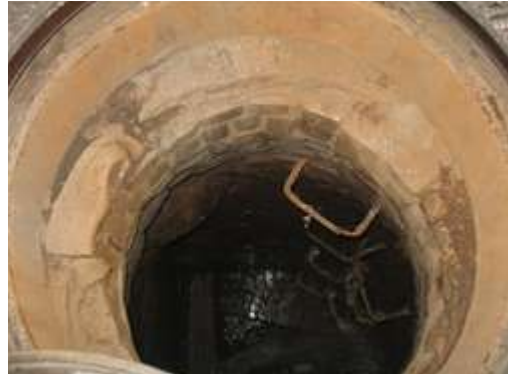
Defect

☒ **Leaks**

Condition: ☐ Sound ☐ Cracked ☐ Root Intrusion ☒ **Loose Brick** ☒ **Deteriorated**

Infiltration: ☐ None ☒ **Joint** ☐ Cracks ☒ **Mortar** ☐ Roots ☐ Wall

Frame leaks. Frame offset. Adjustment deterioration, loose brick and infiltration.

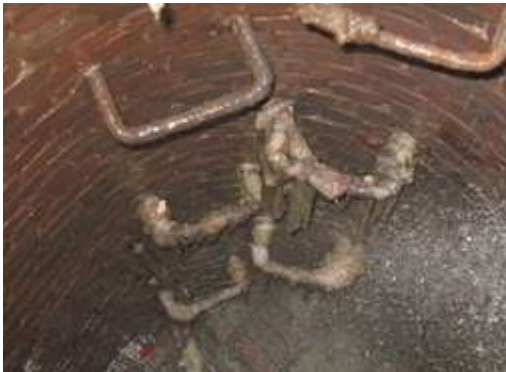
Defect

Evidence of surcharge.

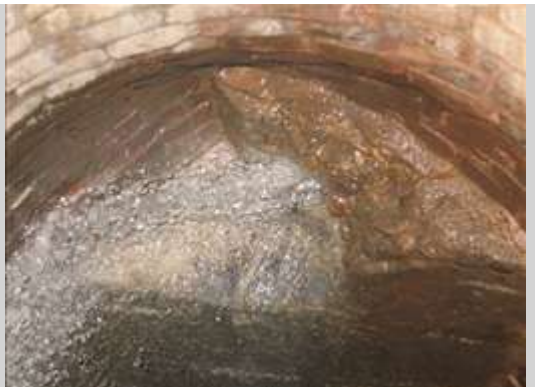
8 in. Circular Gravity Sewer Pipe In @ 2 O'Clock

Deposits: ☐ None ☐ Mud ☐ Sludge ☒ **Debris** ☐ Grease

Silt Depth: **8** (in.) Deposits Extent: **Heavy**

Infiltration: **None** Pipe Seal Cond: **Broken**

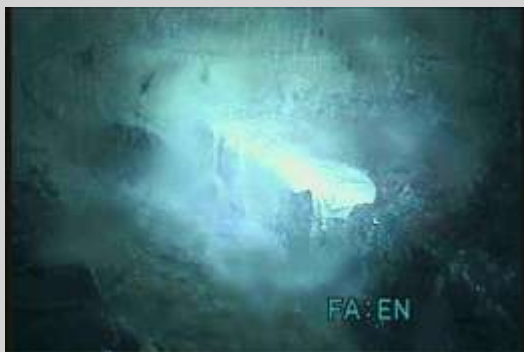
8 in. Circular Gravity Sewer

Deposits: ☐ None ☐ Mud ☐ Sludge ☒ **Debris** ☐ Grease

Silt Depth: **6** (in.) Deposits Extent: **Heavy**
